TS-PIC-9605510R  
August 1996

AERIAL PHOTOGRAPHIC ANALYSIS  
ALTGELD GARDENS

Chicago, Illinois

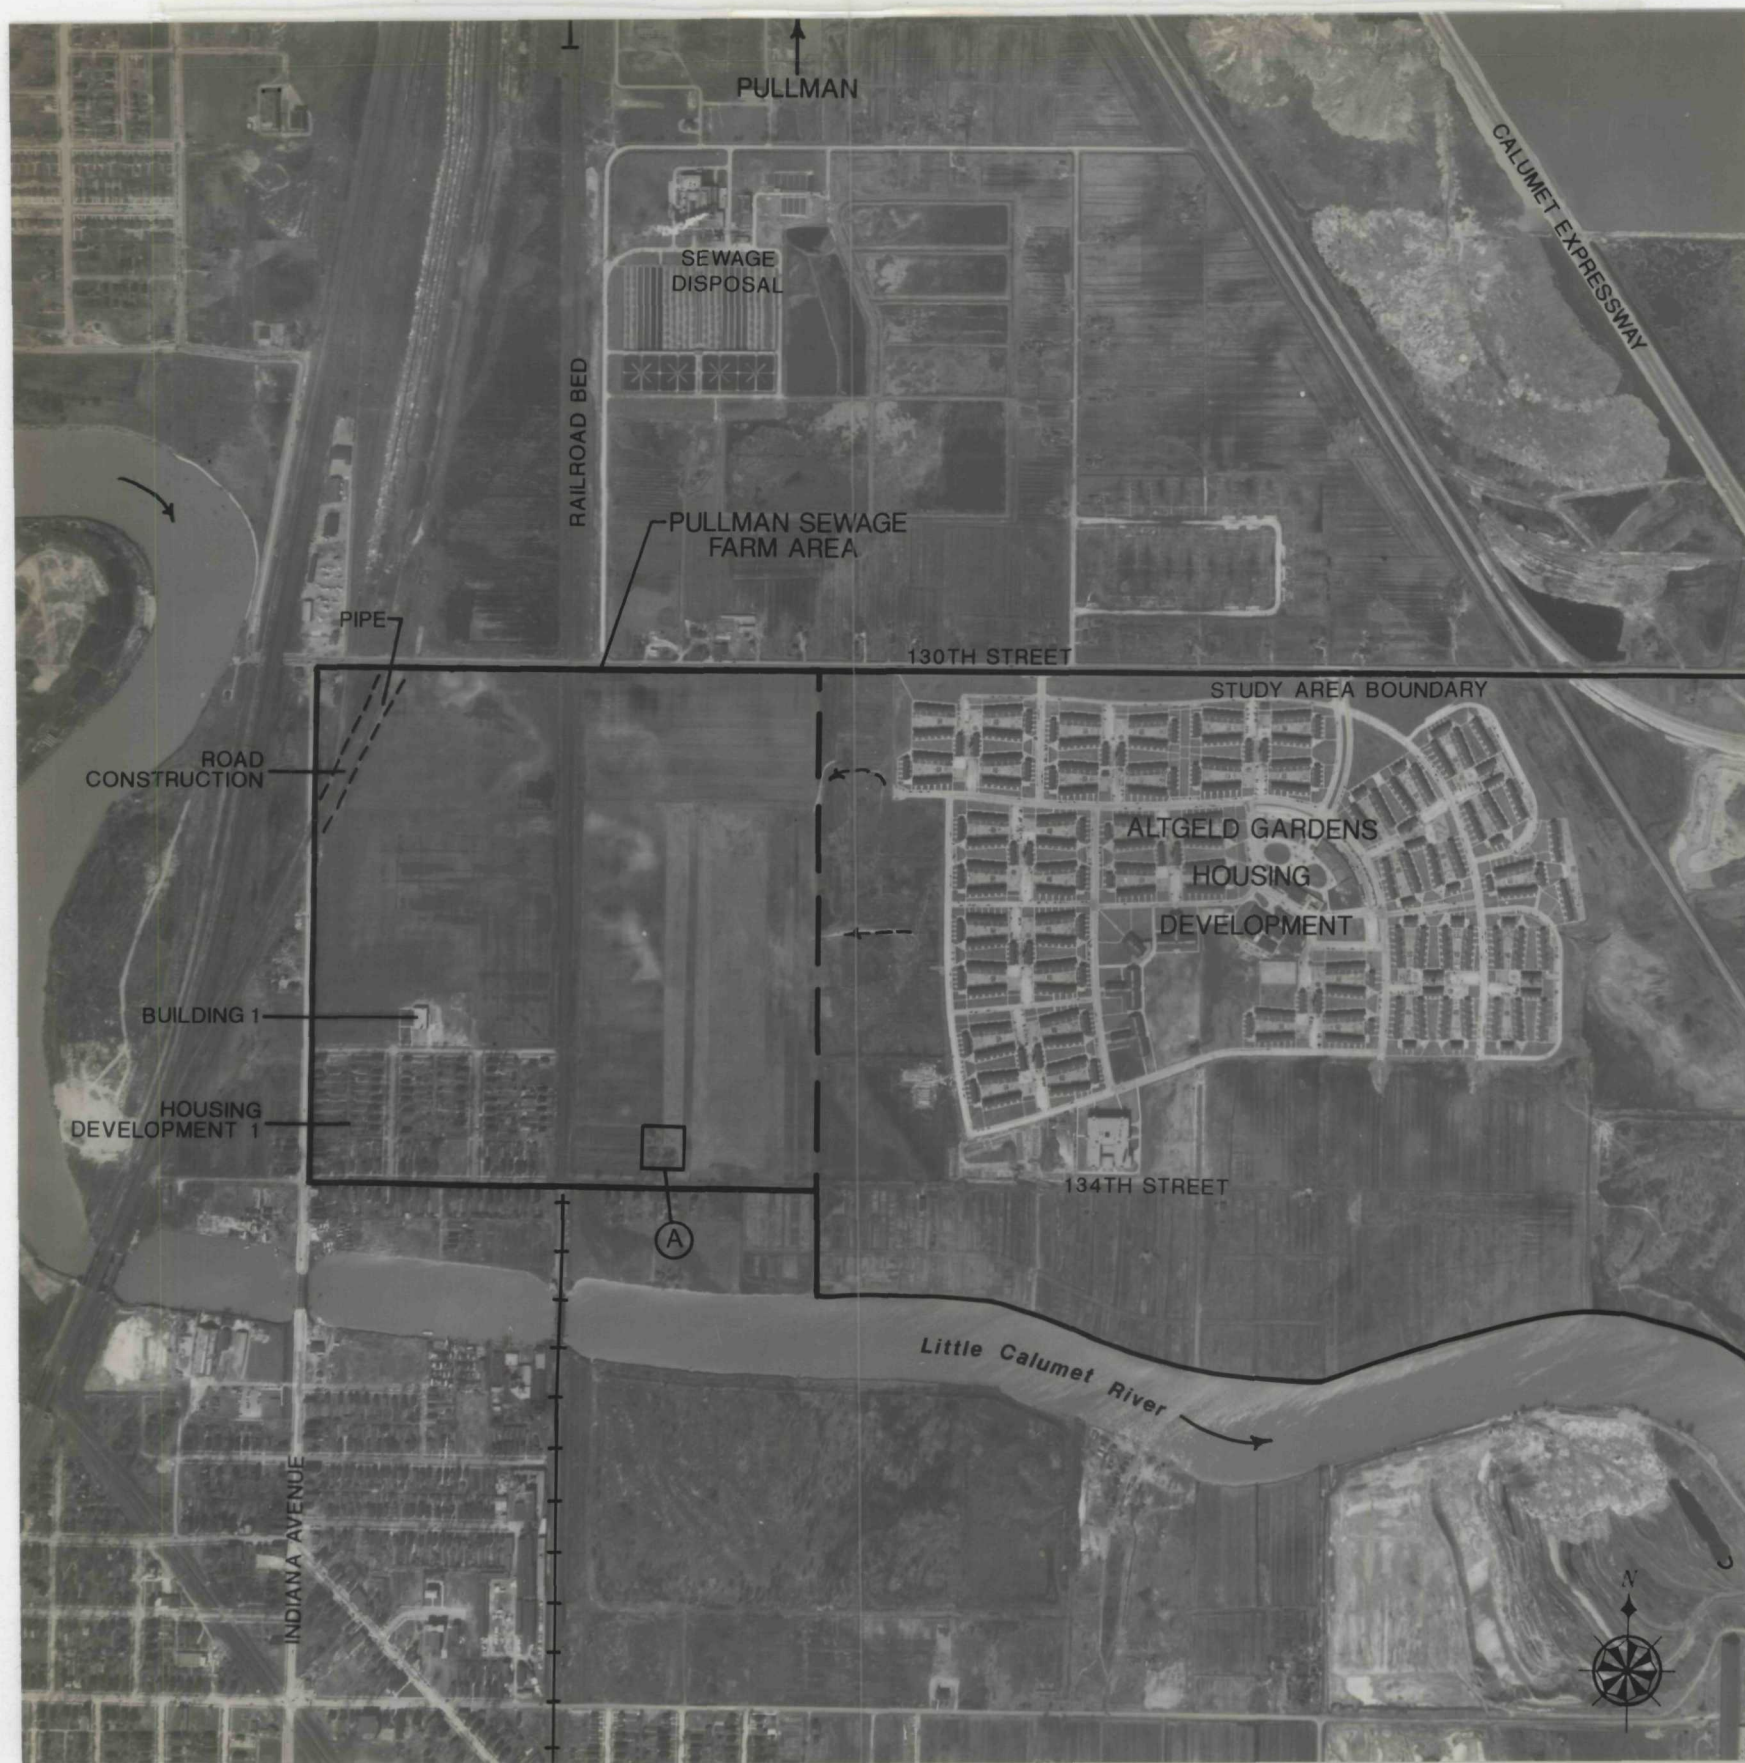
Figure 4. Altgeld Gardens, March 29, 1952. Approximate scale 1:10,740.

The northwest quadrant of the Pullman Sewage Farm area continues to be disturbed by construction activity. An exposed pipe is visible in this area. Much of the study area appears to be either turf or undergoing cultivation. Outside the northeast perimeter of the Pullman Sewage Farm area, there are drainage depressions leading toward the Pullman Sewage Farm area from the Altgeld Gardens housing development. The buildings denoted by Annotation A appear unchanged. No evidence of waste disposal is noted.
